**The Town of Selbyville
Hazard Inspection Committee
Minutes of Meeting August 9, 2023**

EXTERIOR INSPECTION AT 3 LIGHTHOUSE ROAD, SELBYVILLE DE.

On 8-9-2023, I inspected the house exterior at 3 Lighthouse Drive and found the following issues that should be addressed.

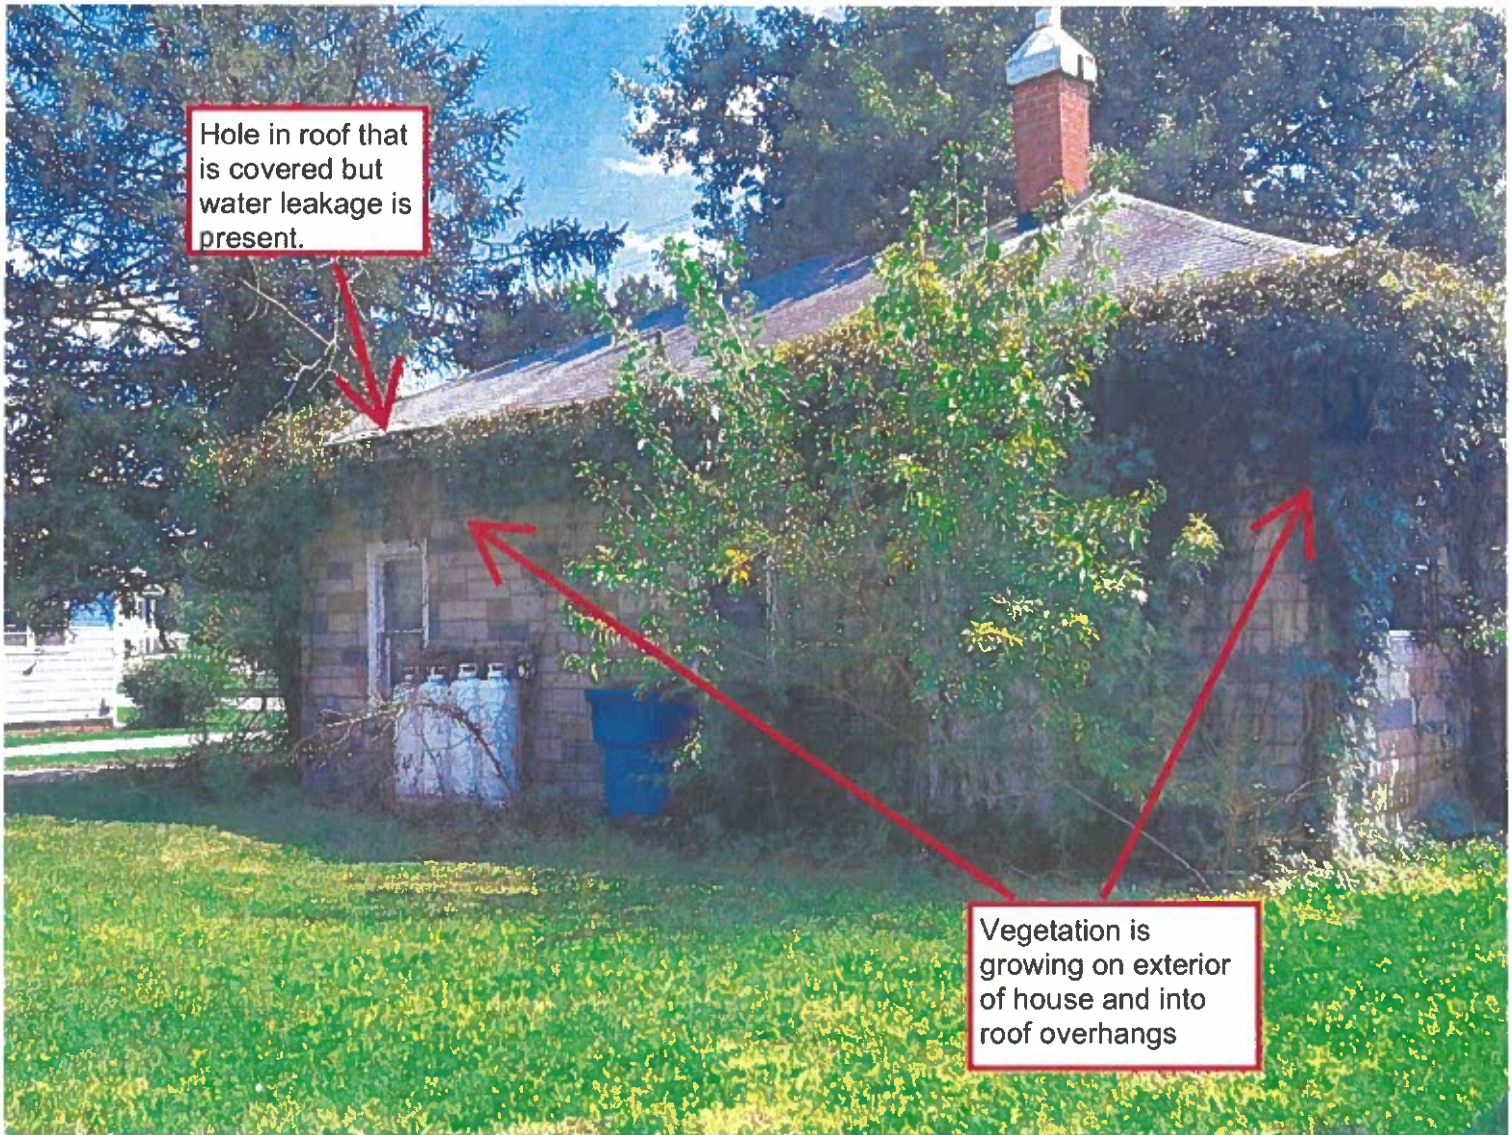
Vegetation is growing on exterior of house and into roof overhangs causing structural issues with the roof sheathing and fascia

Covered entry area roof is damaged

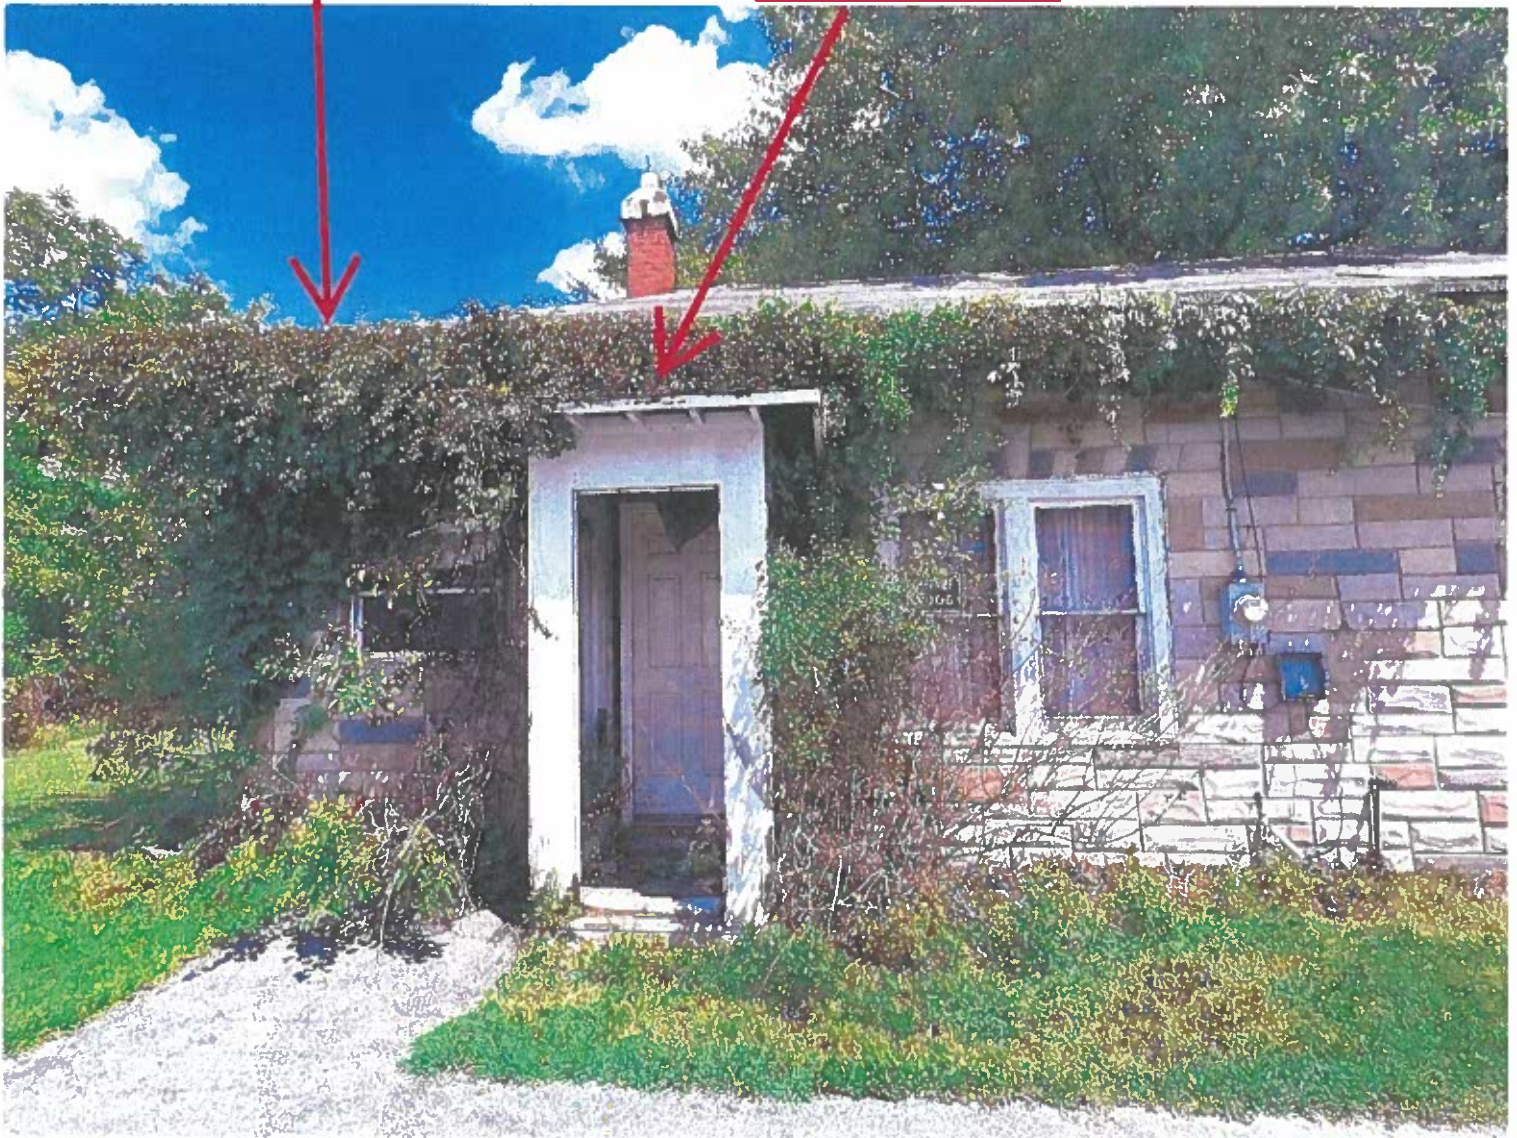
Covered entry area
roof is damaged

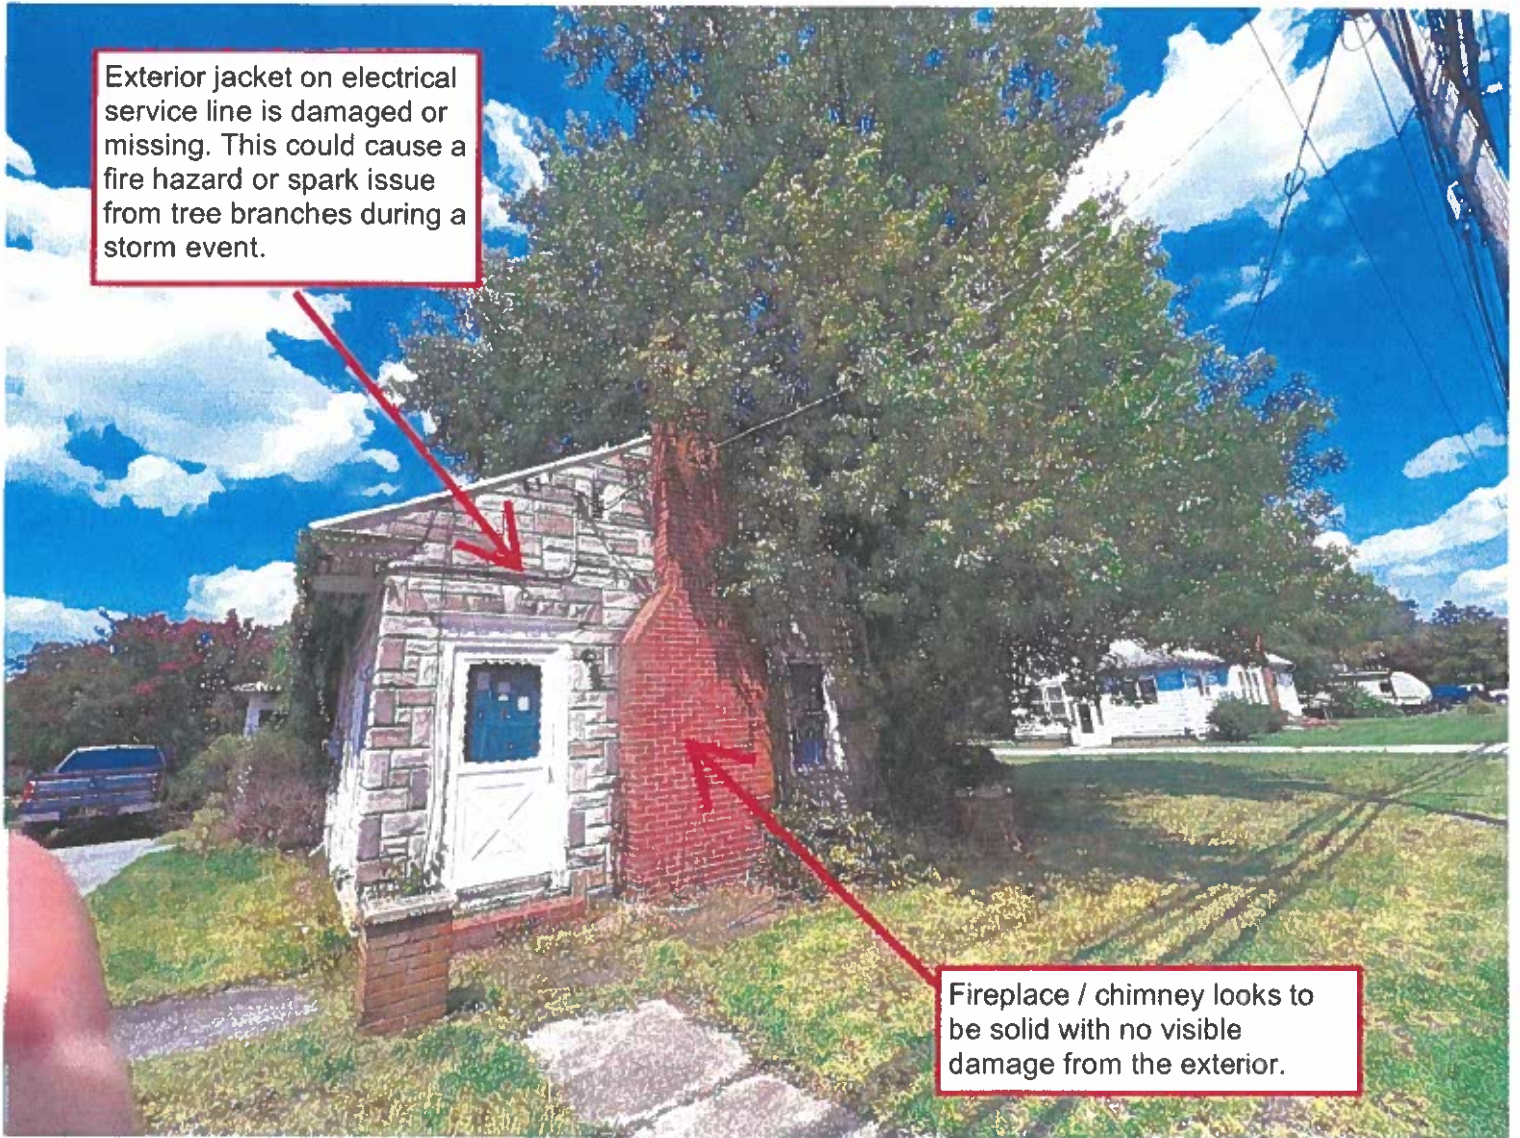
Fireplace / chimney looks to be solid with no visible damage from the exterior.

Location of existing tree could be causing an issue with the house foundation and footer. I could not verify this from the street but due to the age of the house and tree, it is a possibility.

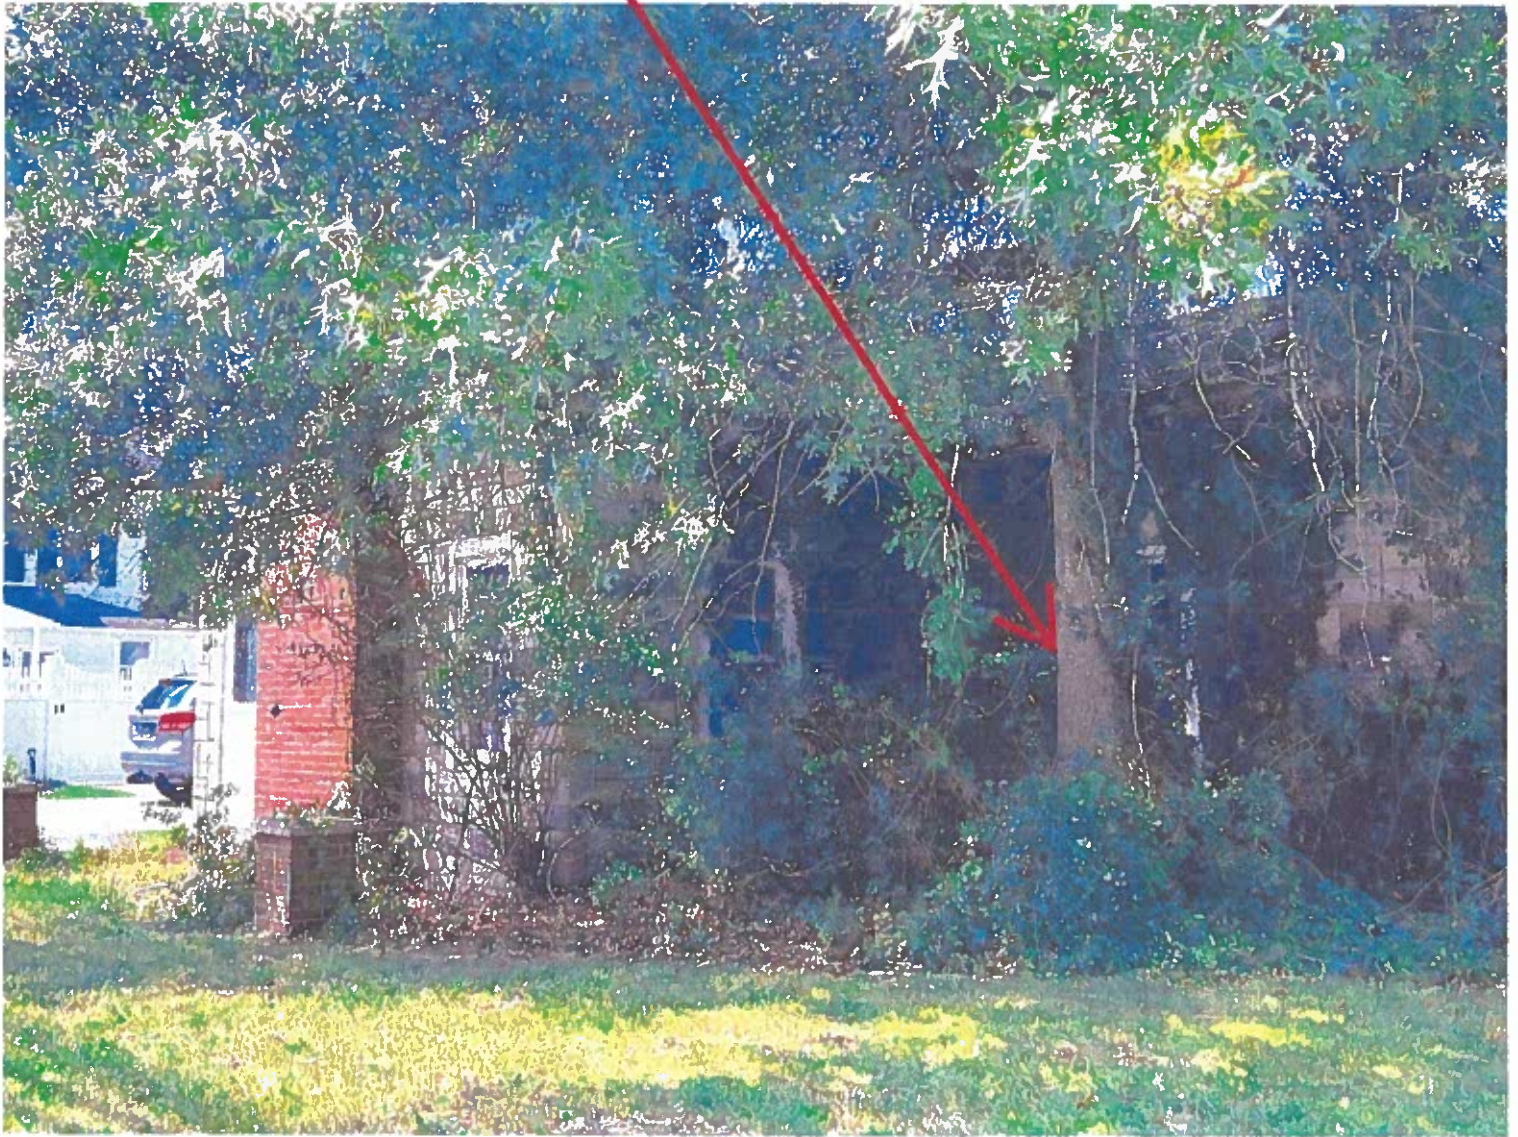
Roof overhang is showing signs of damage which could be causing structural issues

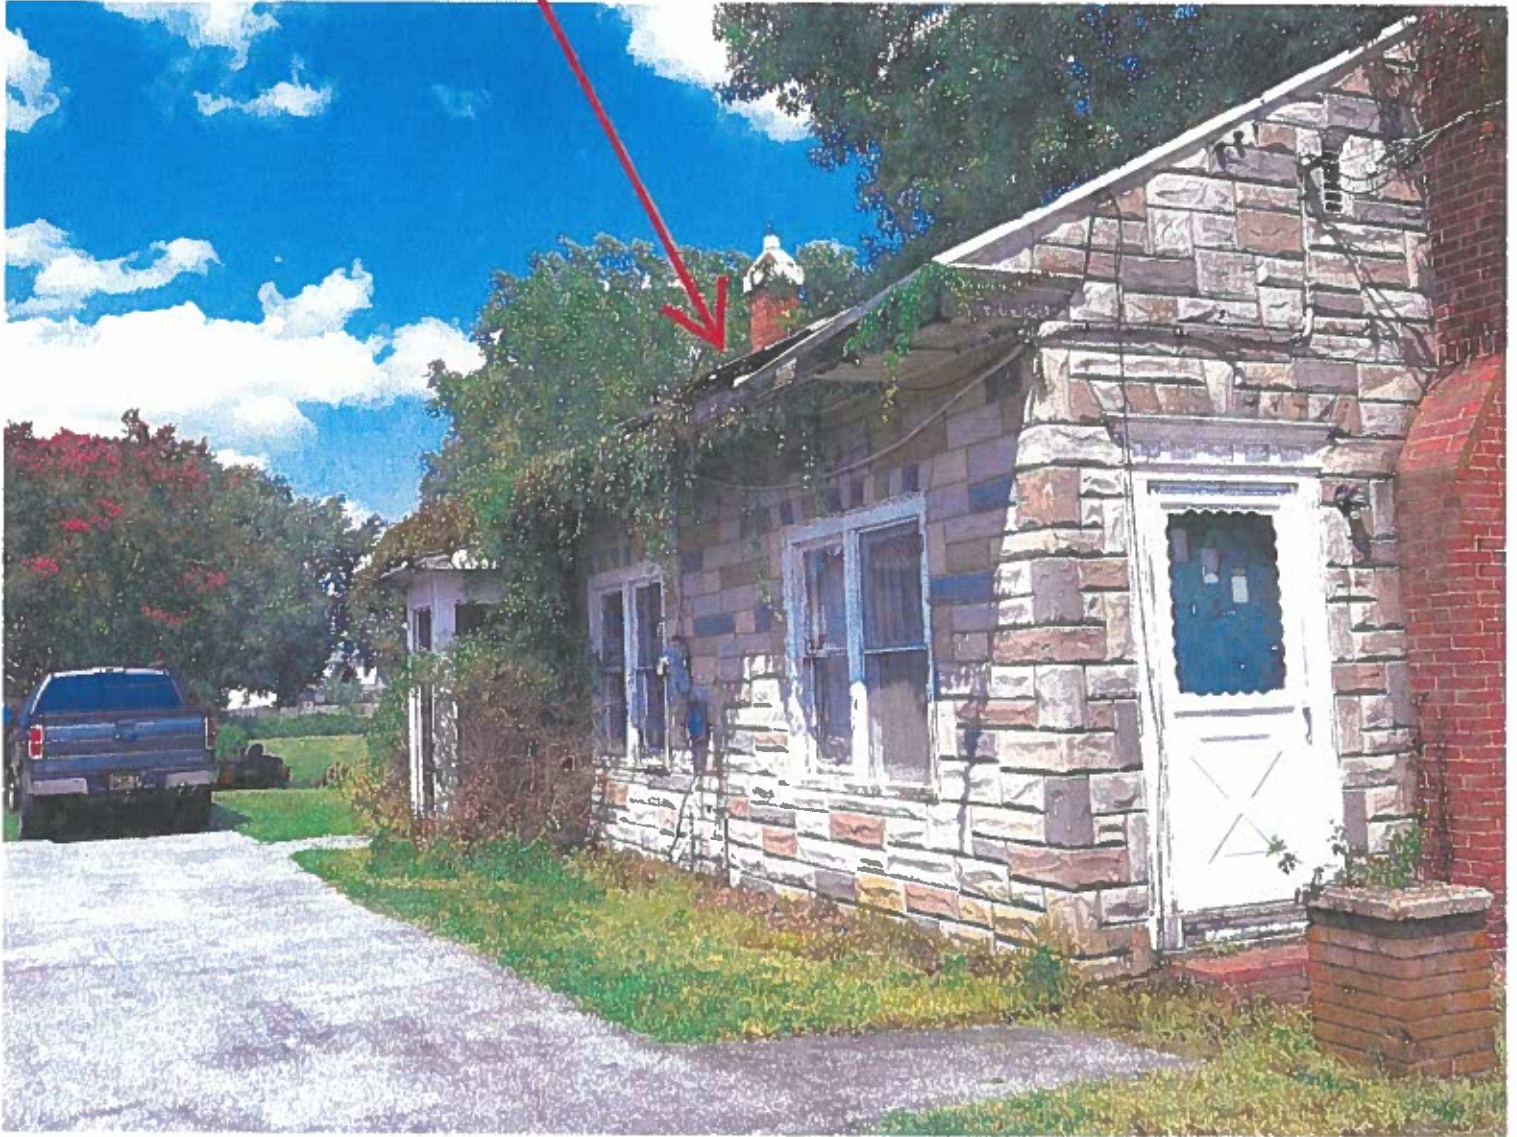
From the street I was not able to inspect the interior corner of the structure, but it appears that the vegetation is causing issues

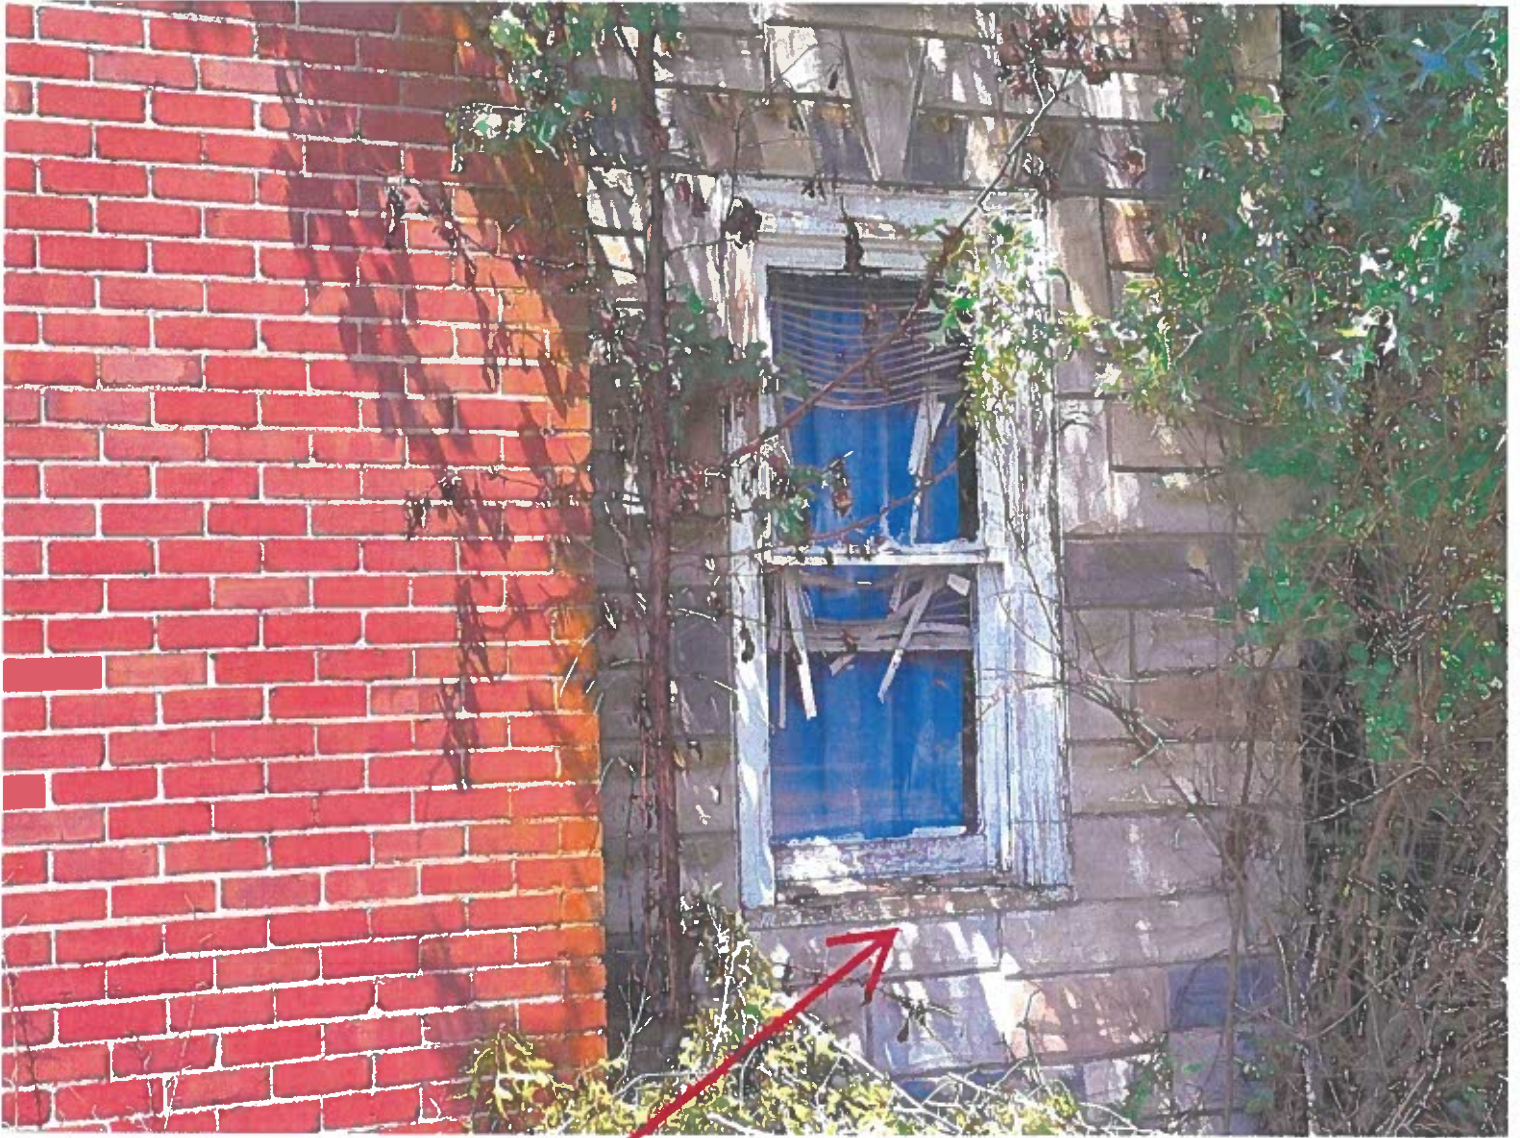
The existing windows do not show signs of broken glass, however the frame and sills are showing signs of rotting and water damage.

Hole in roof has been covered but still open to allow water to get in and weaken structure of the home.

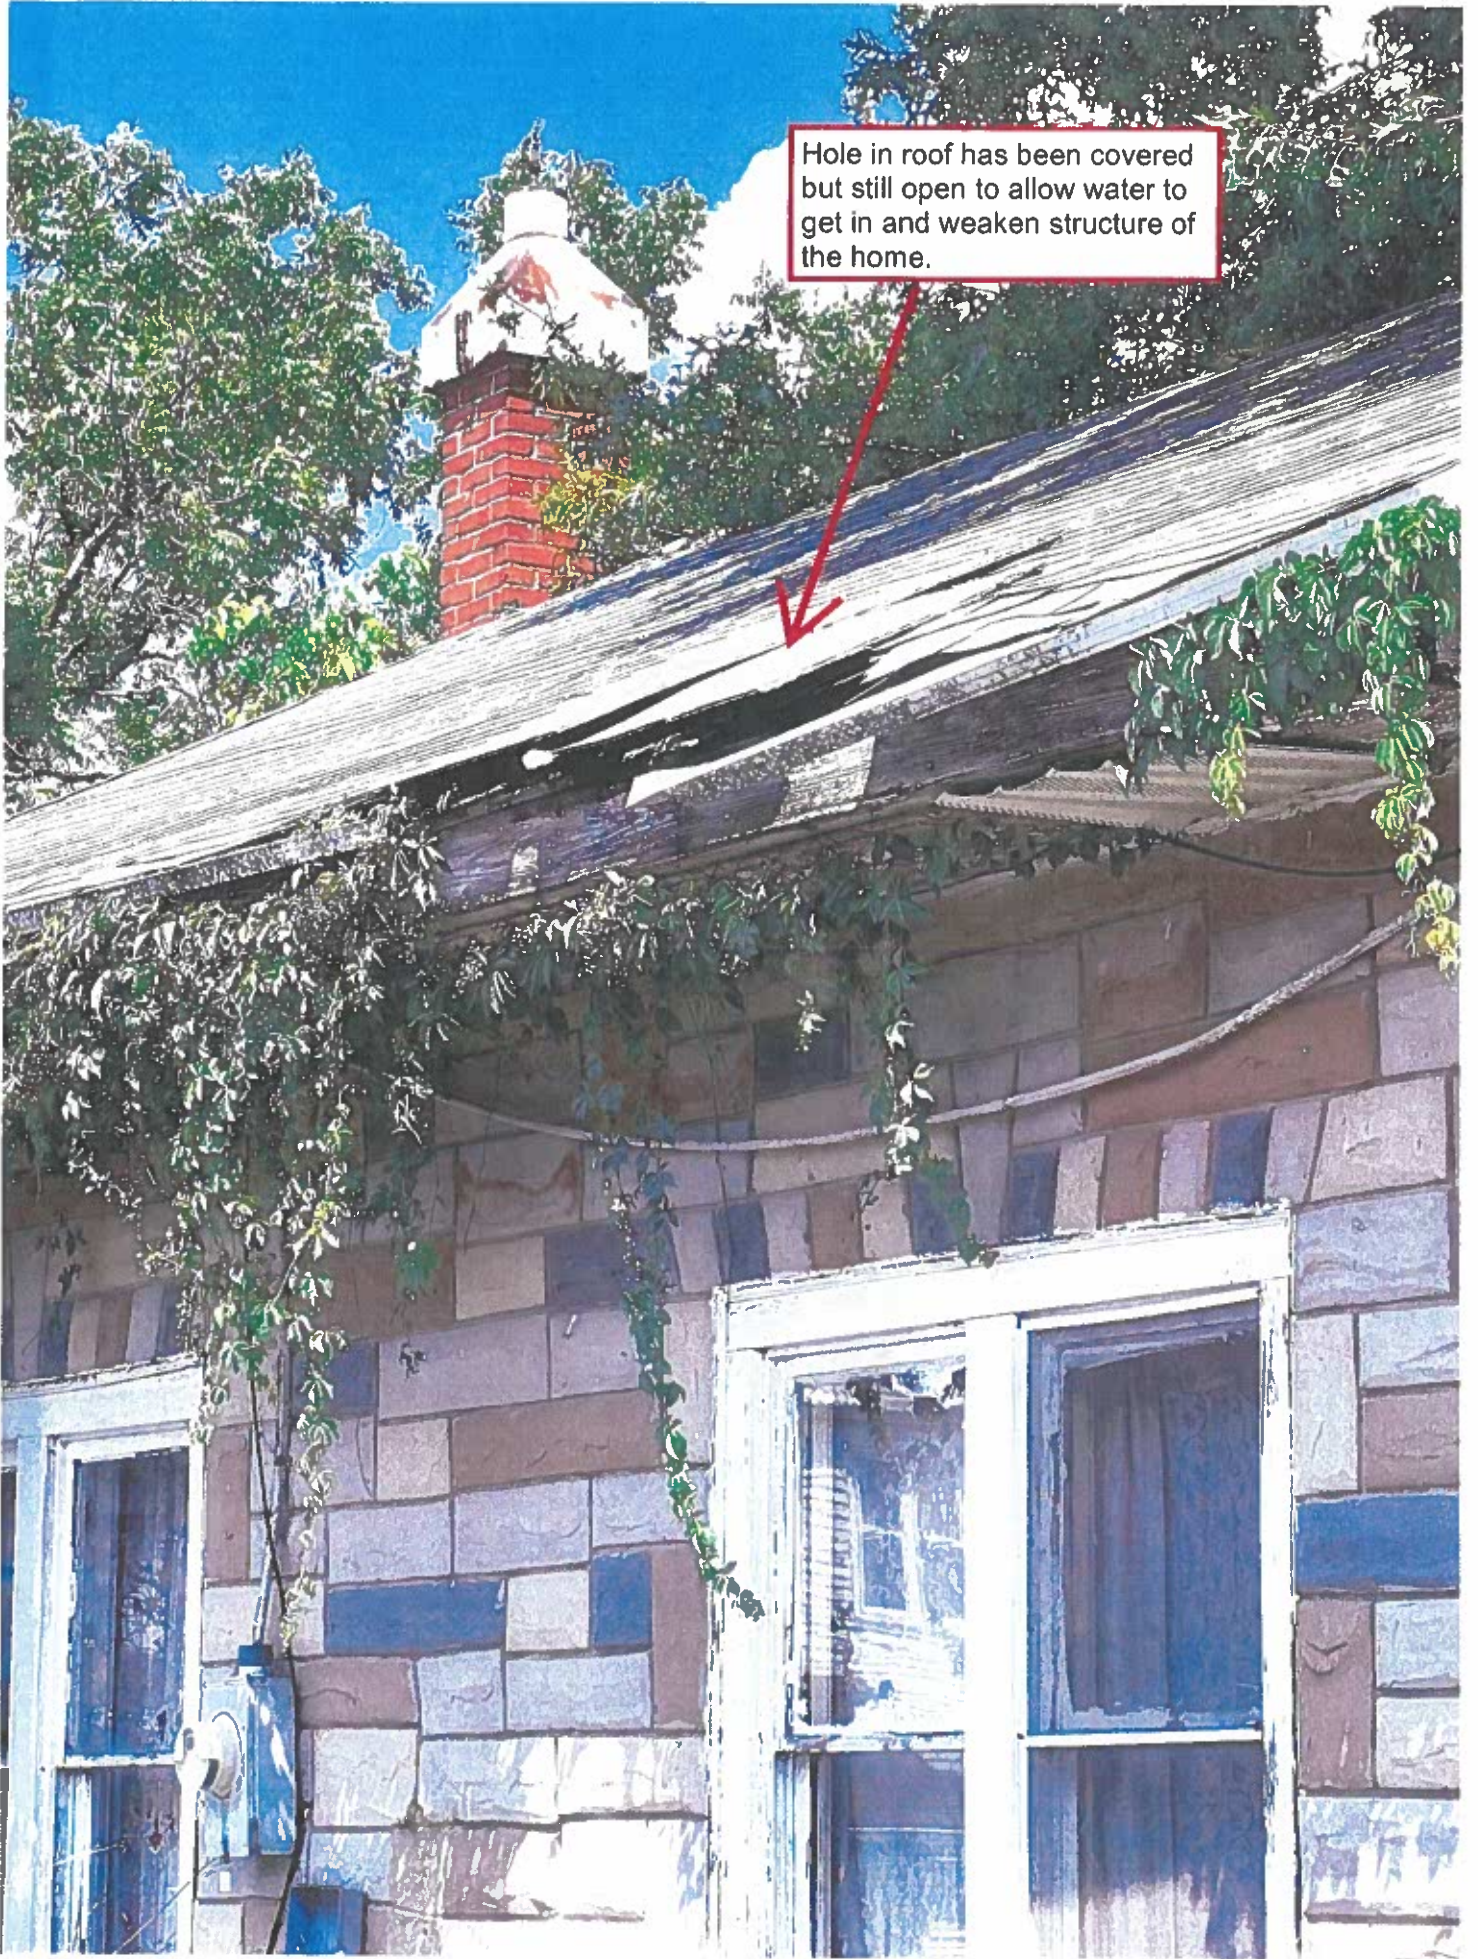
Side entry area needs to be demolished, the entire roof is compromised.

The existing windows do not show signs of broken glass, however the frame and sills are showing signs of rotting and water damage.
