**The Town of Selbyville
Hazard Inspection Committee
Minutes of Meeting August 9, 2023**

EXTERIOR INSPECTION AT 3 LIGHTHOUSE ROAD, SELBYVILLE DE.

On 8-9-2023, I inspected the house exterior at 3 Lighthouse Drive and found the following issues that should be addressed.

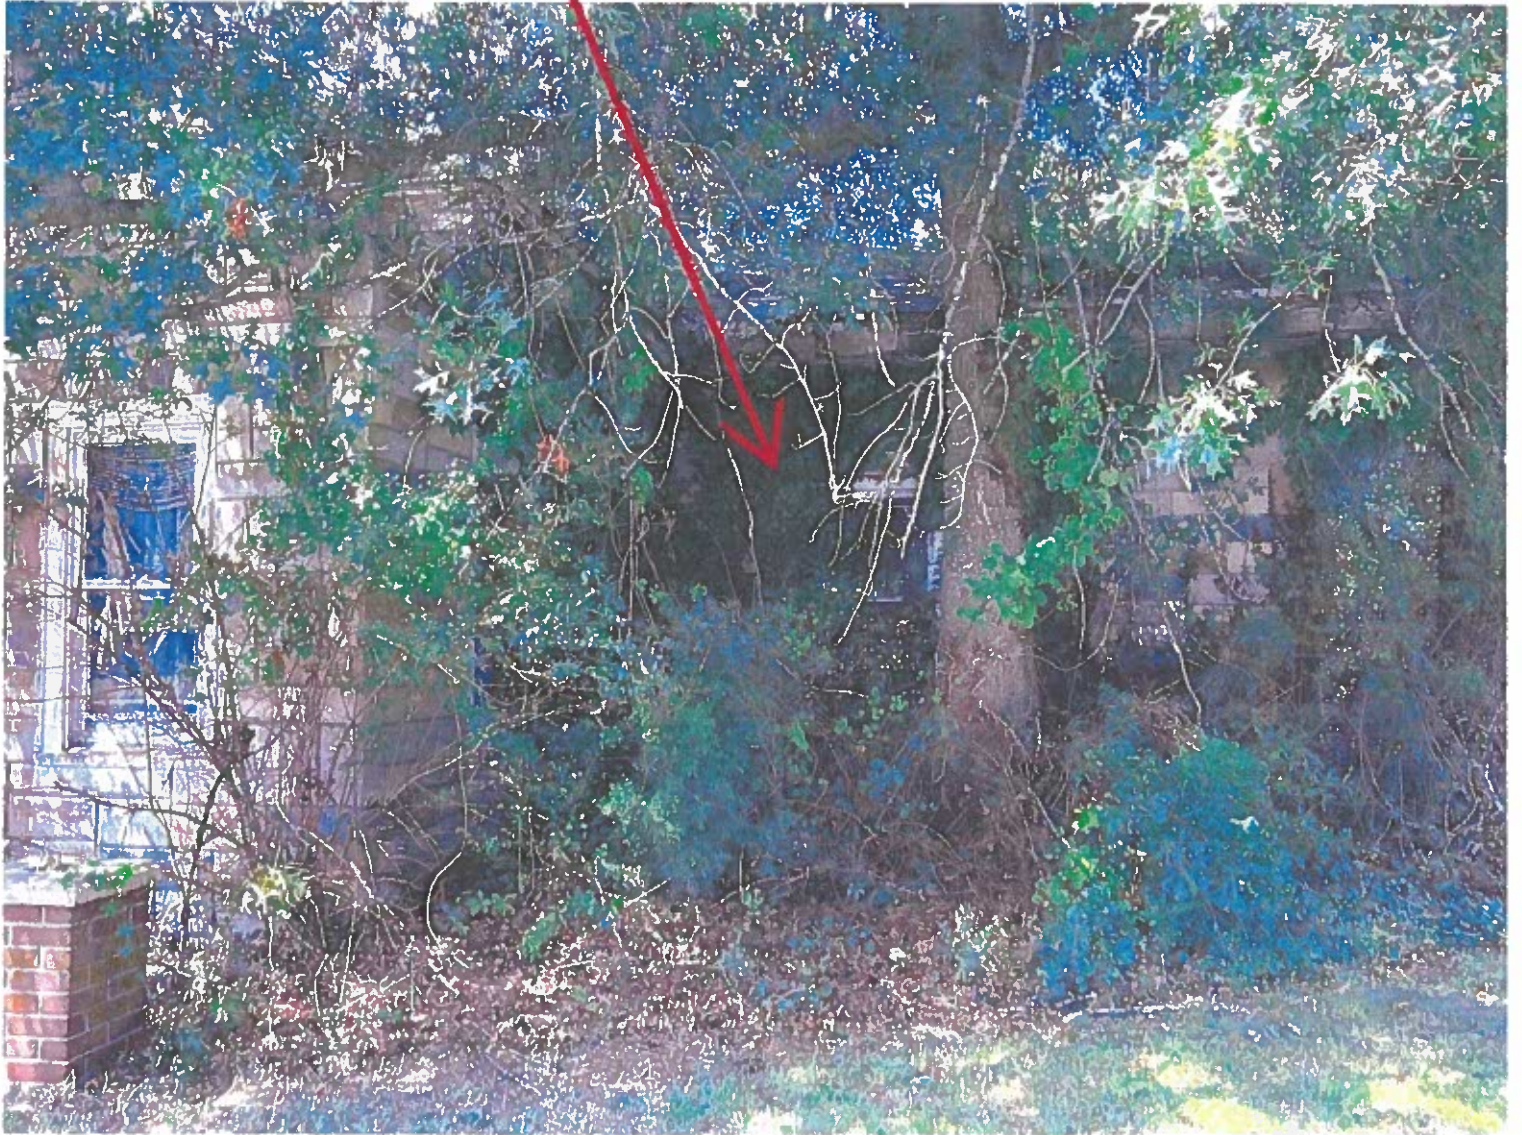
From the street I was not able to inspect the interior corner of the structure, but it appears that the vegetation is causing issues
